# Manhole Inspection Summary

Manhole # S13KK\_038MH

**Location** Address: **BEHIND 2819 WINDSOR AVE** Cross Street: **N DUKELAND ST**

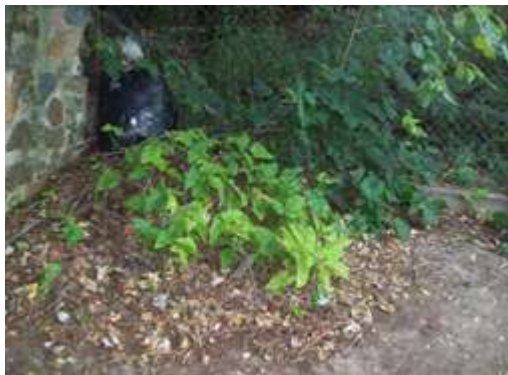
Location View

**Cannot Access - Buried - Manhole Existing Confirmed by CCTV**

Comments **MH LOCATED UNDER DEBRIS SEE LOCATION PICTURES**
